Circle the Wagons: The History of US Army Convoy Security

Richard E. Killblane

Combat Studies Institute Press
Fort Leavenworth, Kansas

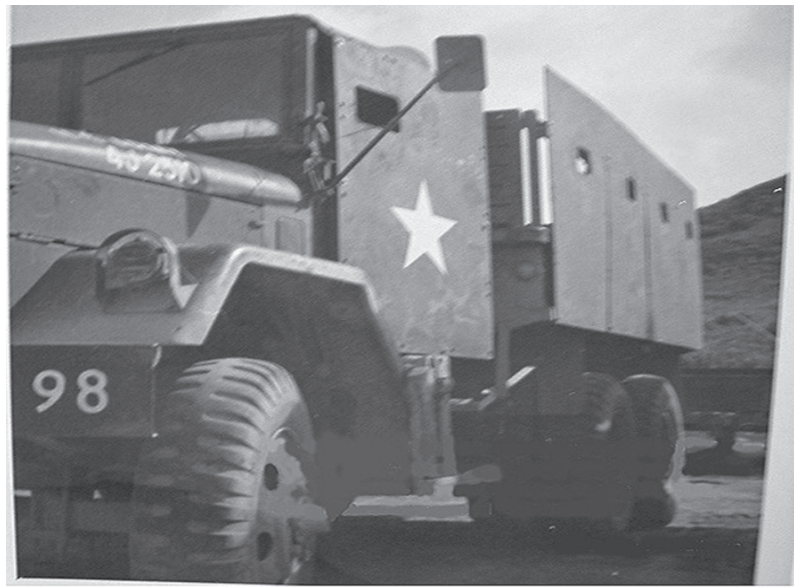
Figure 5. The First Gun Truck.

during World War II; yet, the 8th Group did not have ring mounts and the depot units had no idea what they were and could not order them. As a substitute, Wolfe thought of constructing sandbag pillboxes on the backs of 2½-ton trucks and placing one man in each with an M-60 machine gun. Lieutenant Colonel Phillip N. Smiley, Commander of the 27th Battalion, directed his battalion to build the first two gun trucks.⁴

To protect themselves from mines, the 8th Group crews added sandbags to the floor of their trucks, on the hood in front of the windshields, and even on the fenders. The latter did not work because of the engine's heat and vibration. Warrant Officer Nichols, the group maintenance officer, decided to place steel plating on the sides of the trucks for protection.

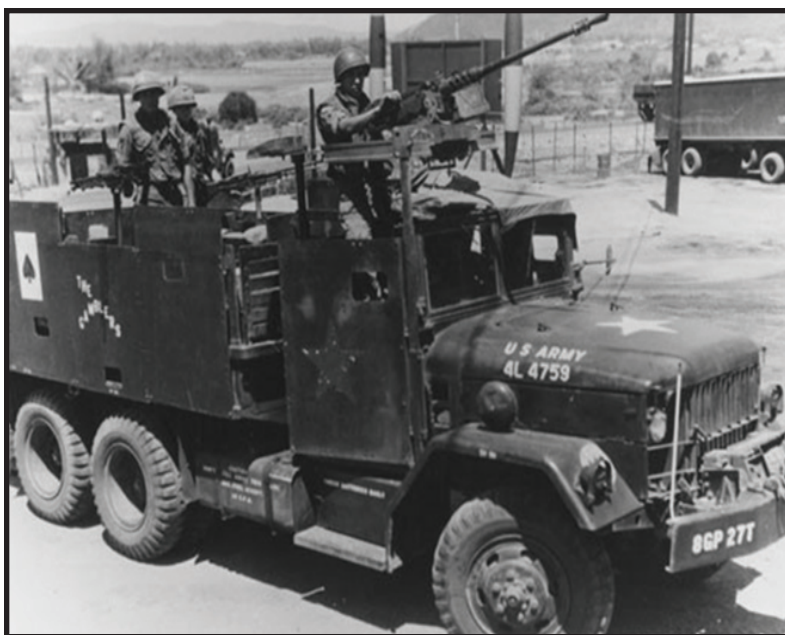
Figure 6. 8th Group 2 1/2-Ton Gun Truck with Steel Plates. This truck has sandbagged floors and two pedestal-mounted M-60 machine guns.

Soldiers scrounged around for plates, finding enough for three to four trucks. This was not the first attempt to harden vehicles in Vietnam. Captain John Horvath, Commander of the 64th Medium Truck Company, had fully armored his convoy commander jeep in the fall of 1966. The 54th Battalion ordered more ring mounts and steel plates, though the plates did not arrive until September. Up to that point, the enemy threat did not generate a greater sense of urgency.⁵

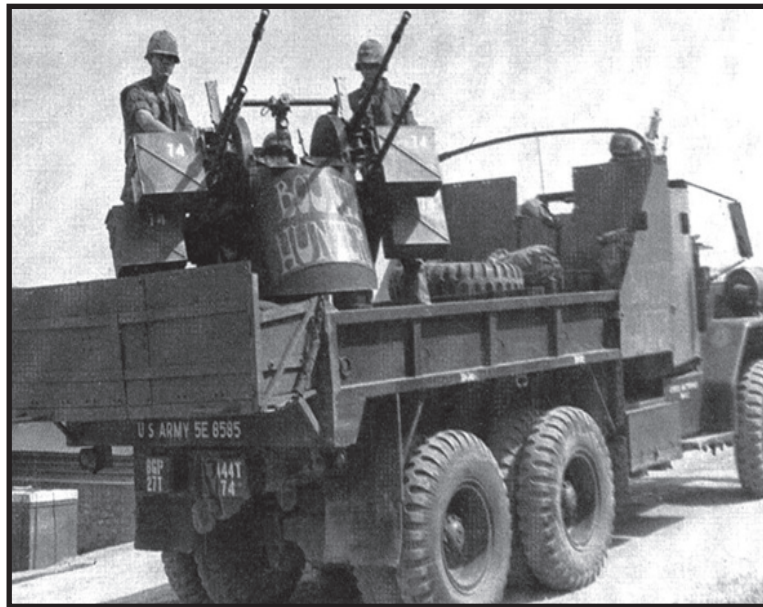
Figure 8. *The Bounty Hunter's* Mounted Quad .50 Caliber.

then hardened cargo trucks by reinforcing driver's side doors with the quarter-inch steel plates and building a box around the bed of the truck with the three-quarter-inch steel plates. The bolt holes and firing port were cut in exactly the same place on the steel plates. These kits were evidently designed in the United States, not in country, since the gunners never fired through the ports. The windshield cover was hinged so that it could be pulled down over the glass with only a small port through which the driver could see. Very few gun trucks used this because it restricted visibility.

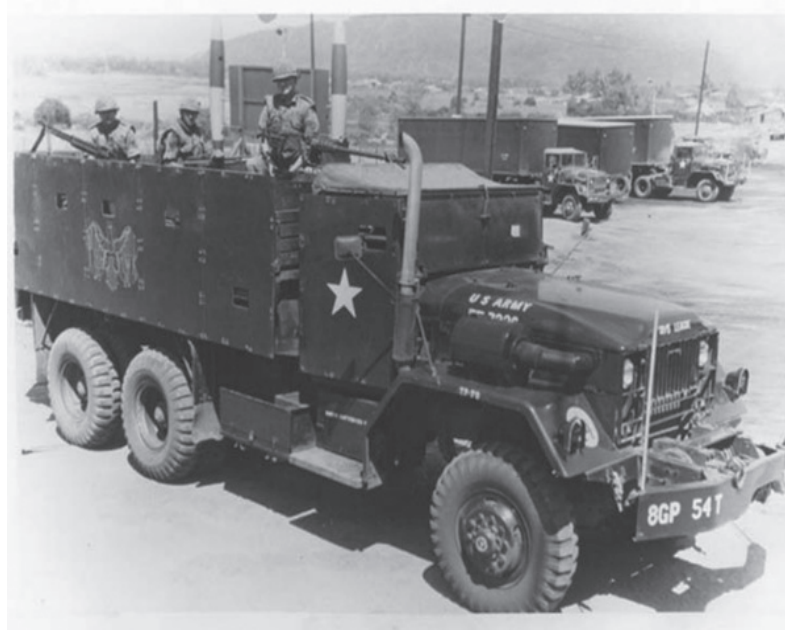
Figure 9. Gun Truck with Gun Ports and Windshield Cover.

These new gun trucks added two M-60 machine gunners in the box. The designers of the kits had cut firing ports in the steel walls thinking the machine gunners could fire their M-60s through them. This was not practical.

The gunners preferred to fire over the top of the walls. The first gun trucks were painted olive drab to blend in with the other cargo-laden trucks.

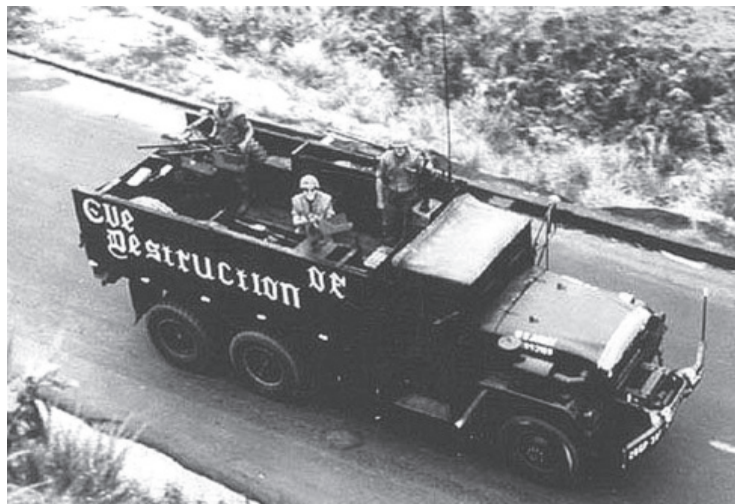
Figure 13. *Eve of Destruction*.

The steel panels alone did not provide adequate protection against RPG rockets, but the various fillers absorbed the spray of the molten metal. Wood provided the best absorbent. The weight, however, placed too much strain on the M35 2½-ton trucks and caused more maintenance problems, so 8th Group drivers began to harden M54 5-ton cargo trucks. They were rated to carry five tons of cargo on unimproved roads but could haul seven tons on paved roads. The M54 had the power and speed needed for a gun truck. One advantage of the box design was that if a truck became inoperable, the mechanics could unbolt the bed from the frame and several wreckers could lift it onto the frame of another truck. A number of double-wall, 5-ton gun trucks, like the *Eve of Destruction*, made their appearance in the summer of 1968.⁴⁴

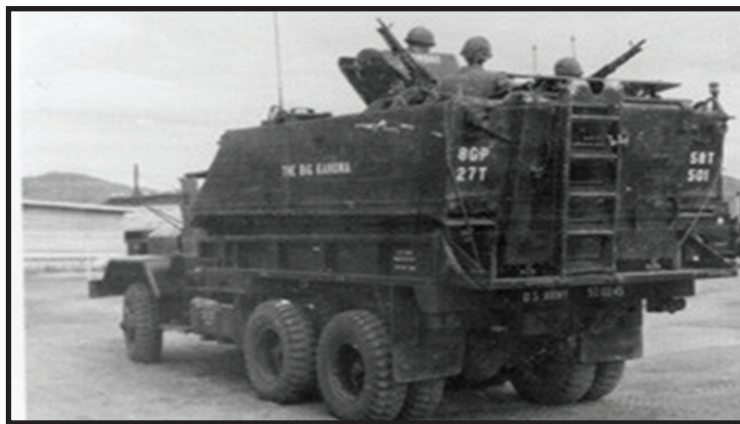
Figure 14. *The Big Kahuna*. APC hull mounted in a 5-ton truck.

This steel shortage caused Bellino to experiment with another idea. 8th Group mechanics mounted a stripped-down APC hull on the back of a 5-ton truck with an M2 .50 caliber and two M-60 machine guns on the top. 8th Group first fielded several APC gun trucks in September 1968. Experimenting further, 8th Group mounted the hull on just the frame of an M54

5-ton truck and another on the bed of a 5-ton. The one loaded on the bed worked best. Colonel Bellino thought this third iteration of gun truck would replace the other types. Unfortunately however, the APC gun truck proved to be very top heavy, hard to drive, and dangerous on turns. The crews of the 8th Group loaded their APC hulls with front forward. This placed most of the weight over the back wheels. The crews down at Cam Ranh Bay loaded their APC hulls in backwards. This distributed the weight more evenly over both the front and rear wheels. Even so, the excessive weight was hard on the vehicle since it required more maintenance to keep it road ready. Its armor offered less protection than double steel panels with filler material and it did not have the firepower of a box-type gun truck. By 1970, complaints had reached 8th Group headquarters, who decided to eventually discard the APC gun trucks. A few did survive in I Corps. The box-type gun truck remained the favorite among crews.⁴⁶

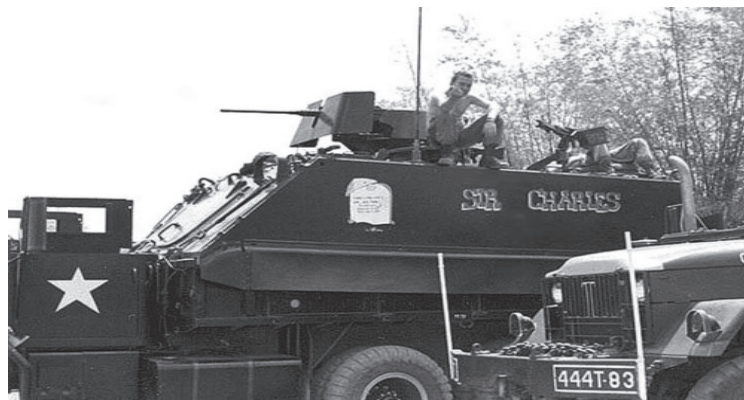
Figure 15. *Sir Charles*, M113 APC Hull.

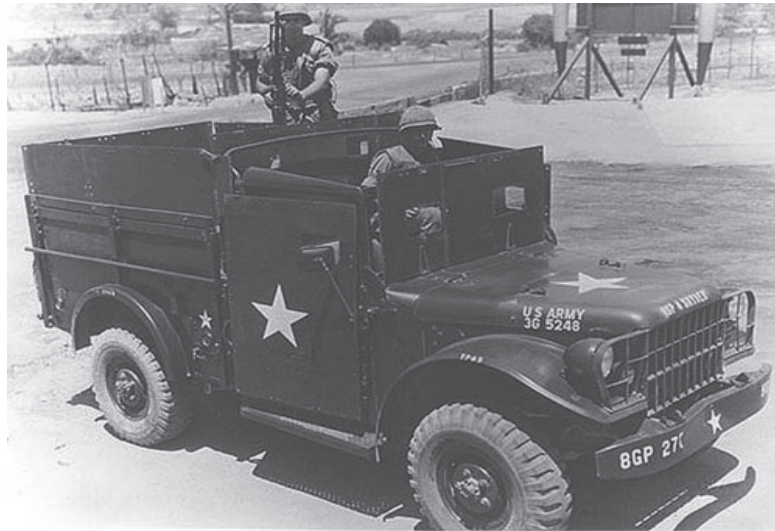
Figure 16. 3/4-Ton Truck.

During 1968, the 8th Group also armored M37 3/4-ton trucks and mounted a machine gun on a pedestal in the back and called them gun “beeps.”

They could only carry thin armor, but offered better protection than an M151 1/4-ton jeep. The added weight did cause considerable wear and tear on the vehicles though. 8th Group also tried using 3/4-ton gun trucks for convoy security but they did not work well either. The gun “beeps” were relegated to administrative runs to Qui Nhon or to driving around at night in unsecured areas.⁴⁷

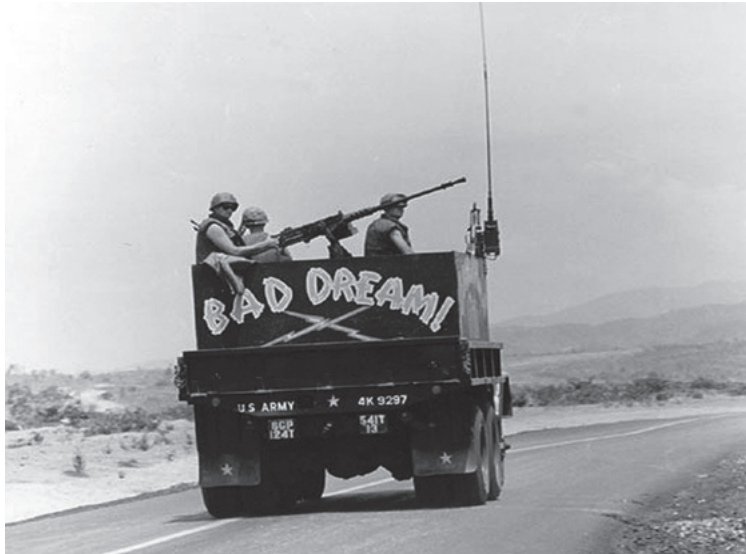
Figure 17. Three Men in a Box with a .50 caliber.

Armament evolution began with hand-carried M-60 and ring-mounted .50 caliber machine guns. Gun truck noncommissioned officers in charge (NCOIC) learned that ring mounts could not effectively traverse 360 degrees, so that machine gun was moved to a pedestal in the box. It was also discovered that the peripheral vision of two men did not encompass 360 degrees. Therefore, the gun truck progressed to a crew of three men in the box. Soon crews mounted all machine guns on pedestals for control and accuracy. As had been learned by earlier truck drivers in the Korean War, the .30 caliber and later 7.62mm (M-60) machine guns were not nearly as intimidating as the M-2 .50 caliber (see Figure 17). The .50 caliber machine gun could shoot through almost anything. By 1969, crews replaced their pedestal mounted M-60s with .50 caliber machine guns or even M134 7.62mm Gatling machine guns, or mini-guns. The mini-gun was the most intimidating, but it tended to jam (see Figure 18). Gun

trucks ended up with three or four pivot-mounted machine guns. Some gun trucks in 1968, mostly APC style, acquired gun shields for their .50 caliber machine guns. The crews learned that the gun shields obstructed their view, however, which was more important than protection, and they gradually disappeared.

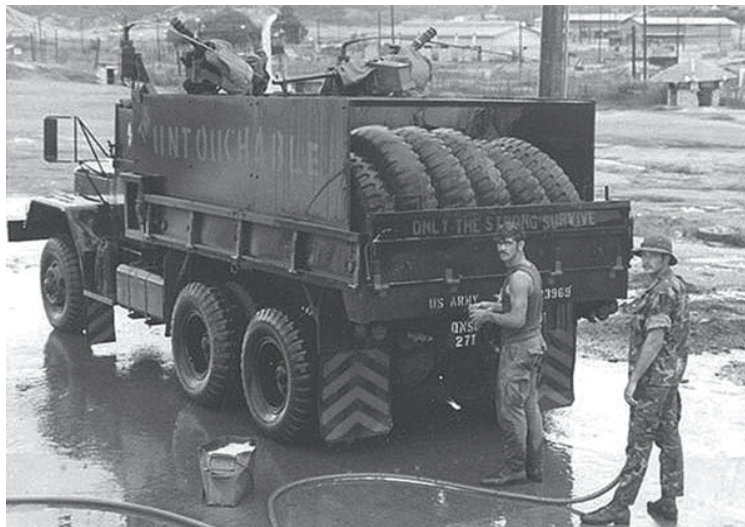
Figure 18. *The Untouchable*, M134 Gatling Machine Gun.

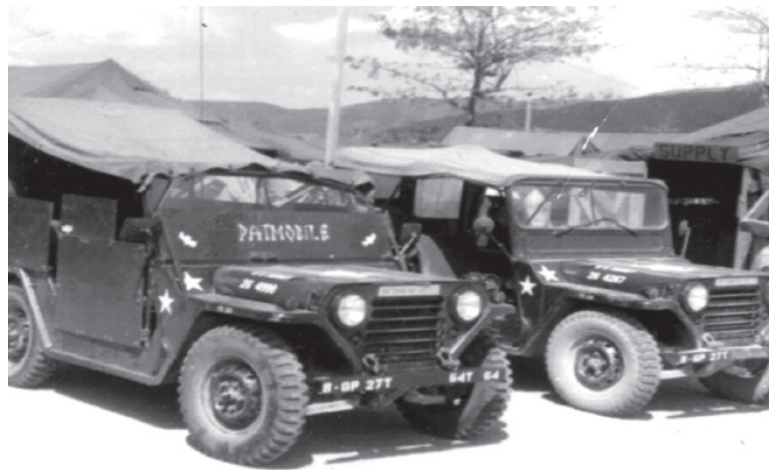
Figure 20. *Patmobile*, Armored Gun Jeep.

Within a year after their origin, the gun trucks had gained a reputation and their crews began to name them. This was nothing new. Soldiers had been painting names on the jeeps and decorating plywood wheel covers for the spare wheels well before September 1967. In 1966, Captain Horvath had named his gun jeep the *Patmobile* after his wife and the TV series *Batman*.

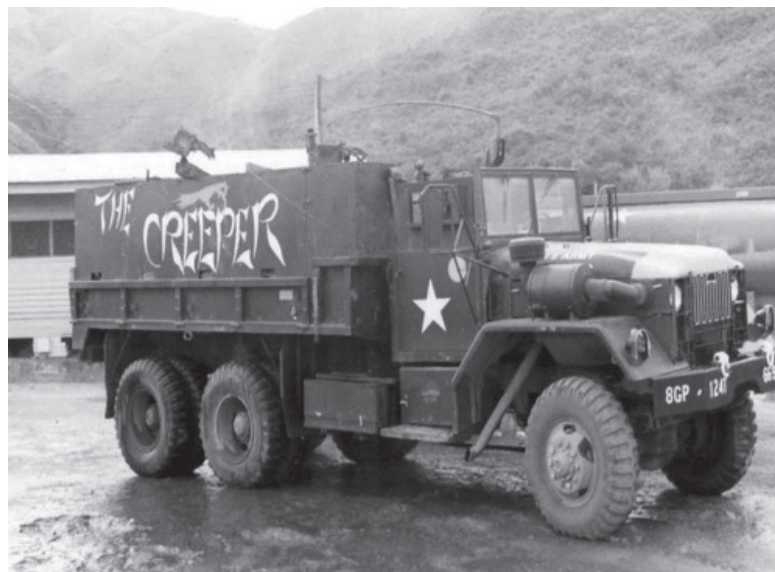
Figure 21. *The Creeper's* Bullet-Proof Windshields.

In 1969, gun trucks also received new bullet-proof windshields since the others were impractical. Instead of ports, the new windshields had pre-cut rectangles with slots for two 2-inch thick bullet-proof sheets of glass. These began to see widespread use on gun trucks. If damaged, the old glass could be slid out and be easily replaced with a new sheet.

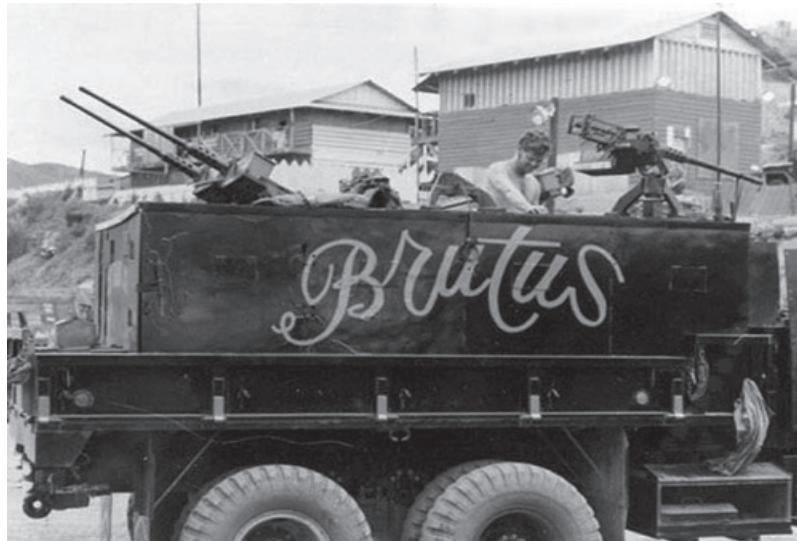
Figure 22. *Brutus*, Three .50 Calibers in a Big Iron Box.

Probably the most dangerous gun-truck mission was escorting fuel convoys, with each tractor hauling 5,000 gallons of high explosive jet fuel. Enemy forces preferred to hit fuel tankers because the resulting fire usually blocked the road and trapped the other trucks. The 359th Medium Petroleum Truck Company contained the gun trucks *Misfits*, *Brutus*, *Outlaws*, *Woom Doom*, and *Ball of Confusion*. In 1970, *Brutus*' crew consisted of William "Bill" Kagel, Ernest "Ernie" Quintana, and Sergeant Jimmy Ray Callison. Ronald "Ron" Mallory, Richard Bond, and Chuck Hauser became friends with the crew of *Brutus*.
